REPORT
ON
ARCHÆOLOGICAL WORK IN BURMA
FOR THE YEAR 1904-05.

REPORT

GOVERNMENT ARCHÆOLOGIST, BURMA,

For the Year ending 31st March 1905.

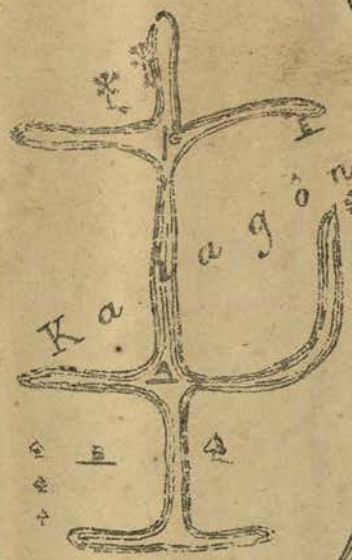
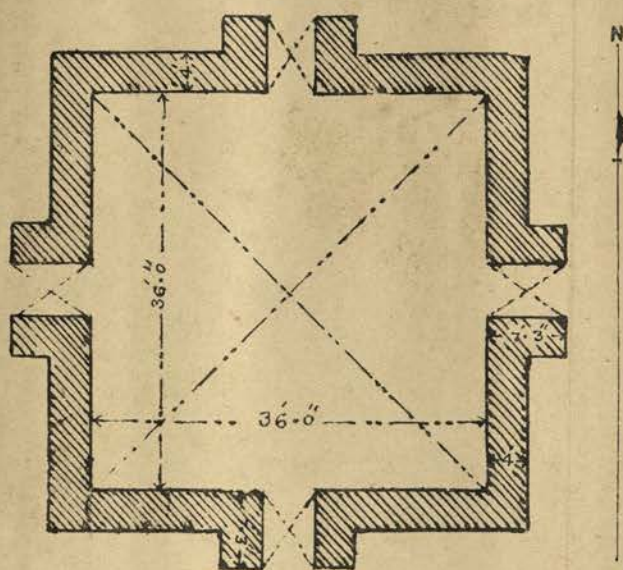
Plan
OF
HALENGYI.

The lithic record was found, most accidentally, by a cartman, who was digging for road-metal and stone, required by the Public Works Department. It was found a little to the south of the south-eastern corner of Halingyi city and the spot is shown on the plan.

The excavations lasted from the 8th to the 15th February 1905, and were made at the following places: (i) Kalagôn; (ii) Payagôn; (iii) Palace site; (iv) a *pôngyi's* tomb near the Tawya-gu Pagoda; (v) three ruined pagodas to the south-west of the Nagayôn tank; (vi) a spot on the west bank of the Nagayôn tank, where the Sanskrit inscription was found; (vii) a dry nullah close to the western wall of the palace; (viii) Kaladaik at the south-eastern corner of the city; (ix) an ancient well near the south-western corner of the palace enclosure; (x) an ancient tank just outside the northern wall of the palace.
